# Dozens of Terēan Clients in California and Nevada: *30-min Survey Locates Calaveras Fault in Pleasanton*

# Las Vegas Valley, NV Fault Strands from Terēan Client Work

# One-Day Surveys Show Basin-Floor Faulting to 1 km Depth

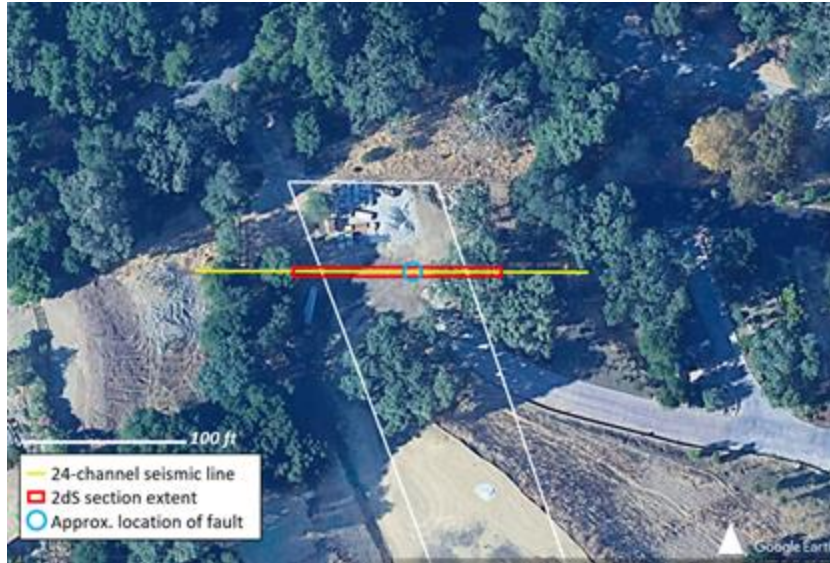
- ReMi 2dS<sup>®</sup> survey on 230-ft-long 24-chan geophone array took 30 minutes

- Active strike-slip fault projected to 100-ft-wide zone
- Lateral Vs discontinuity locates fault to 10 ft accuracy
- Targets paleoseismic trenching

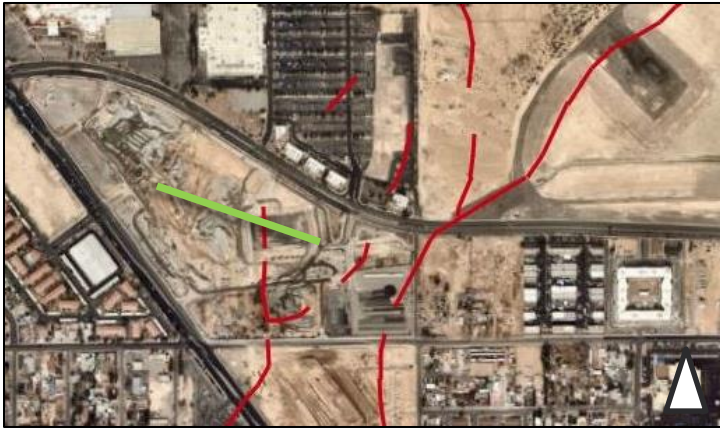
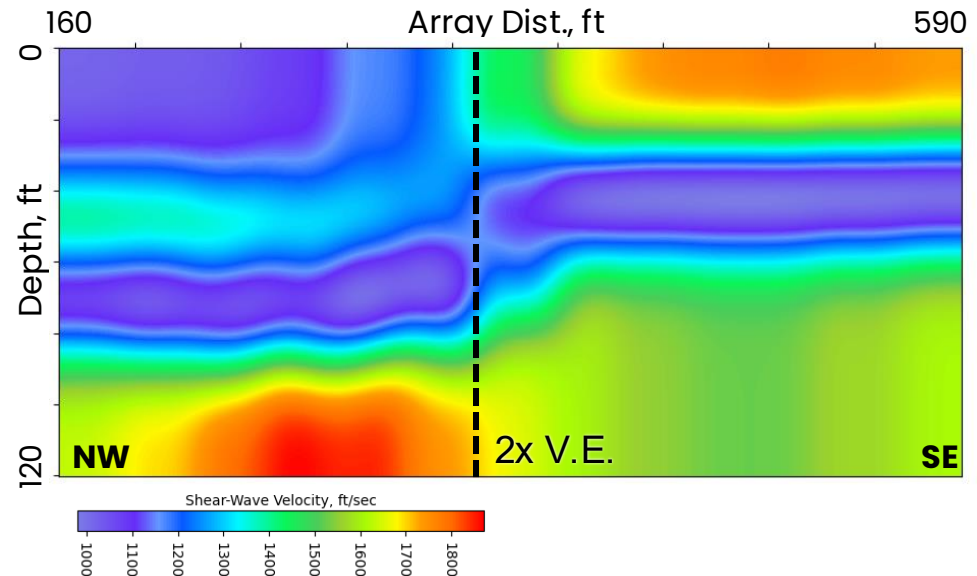
- ReMi® software 2D S-wave velocity image (right) from Las Vegas Valley. Caliche layer (orange and green) overlies displaced velocity reversal (blue)
- Fault manifests as a lateral velocity discontinuity at the center of the line, confirming dePolo's location.

- Inferred fault locations (dePolo)
- 24-channel ReMi™ array 230 m long; 75-min survey

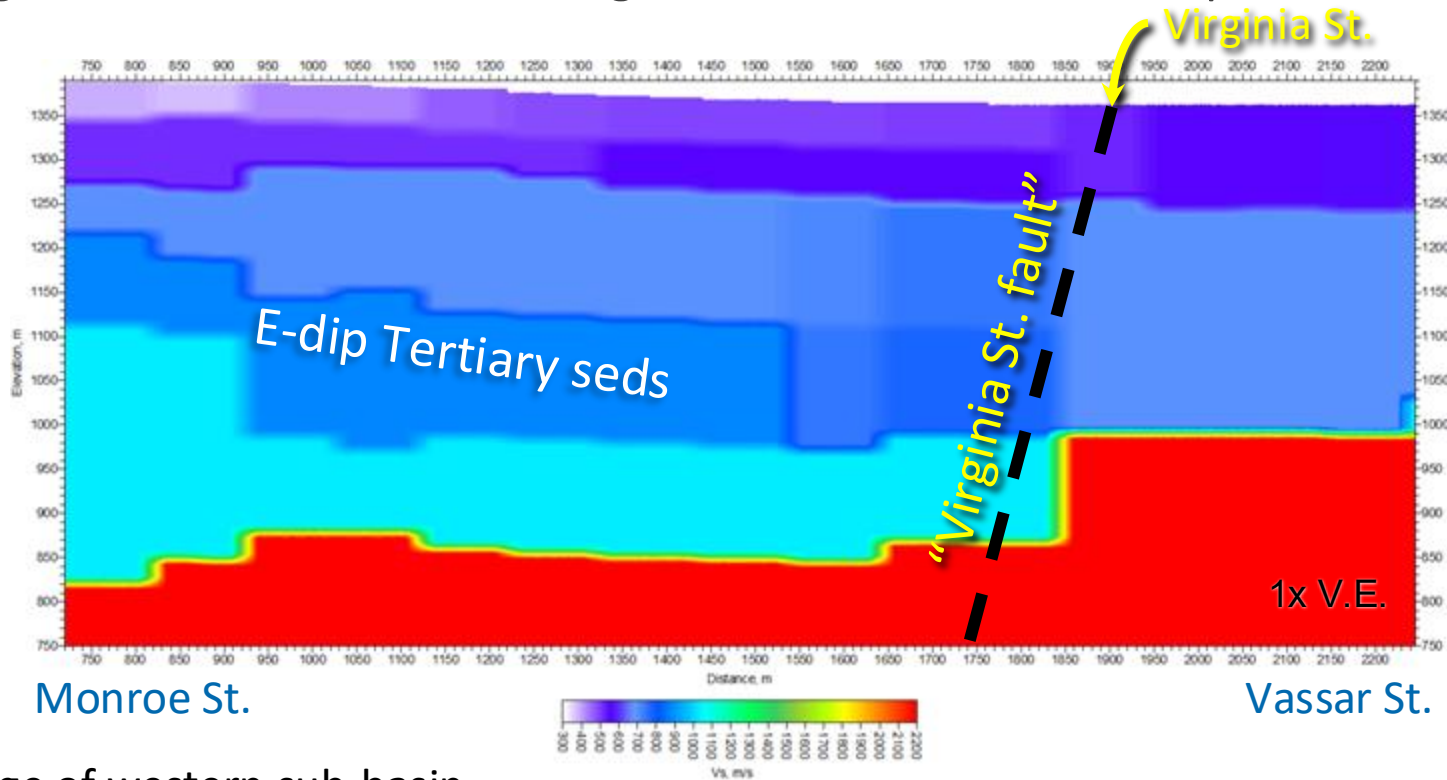
2015 Line 2

Imaging Structure Below Reno: “Virginia Street Fault” – USGS Sponsored

550 m depth

Across east edge of western sub-basin

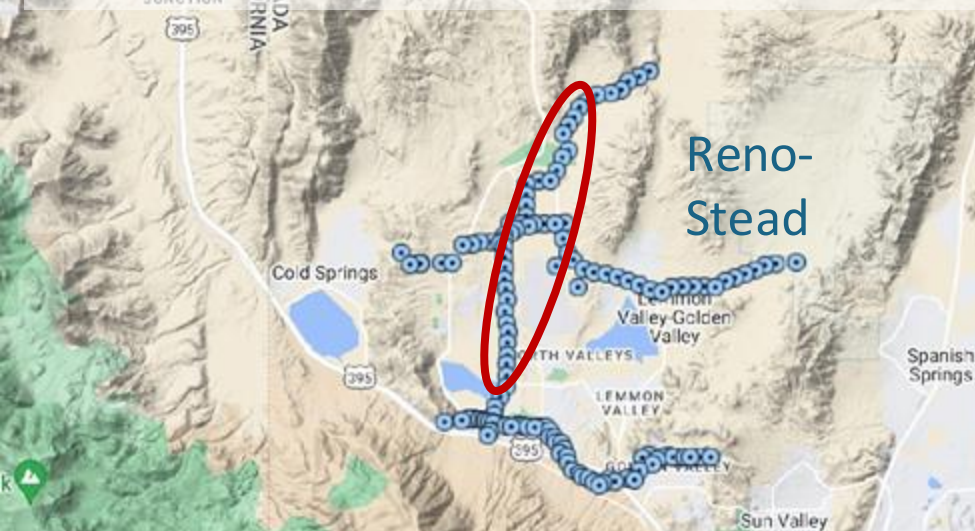
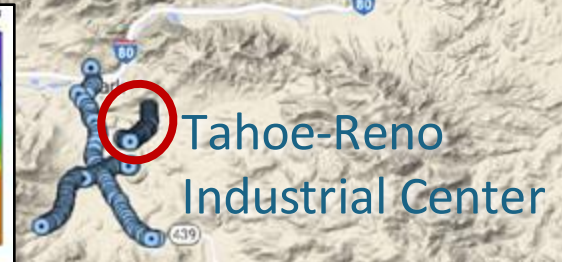
*The Univ. of Nevada in collaboration with the Univ. of Cincinnati profiled the 700 m deep 2-level basin below Lemmon Valley (Reno-Stead); and several complex, smaller basins in the Tahoe-Reno Industrial Center (TRIC). Deep ReMi shear-wave velocity sections from Terēan analyses.*

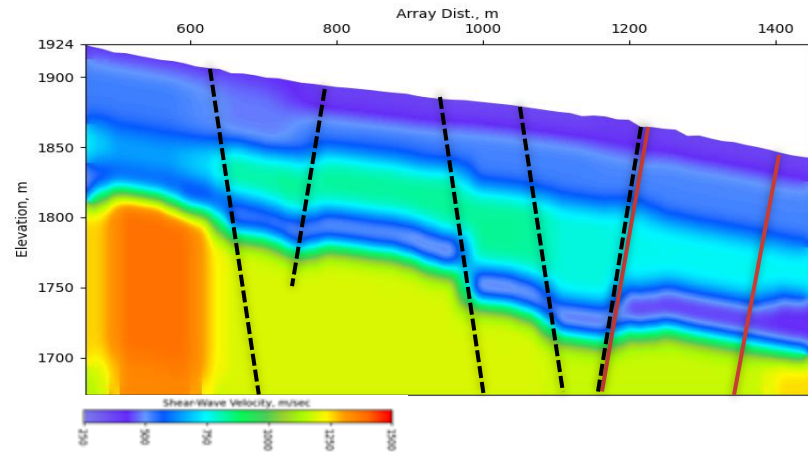
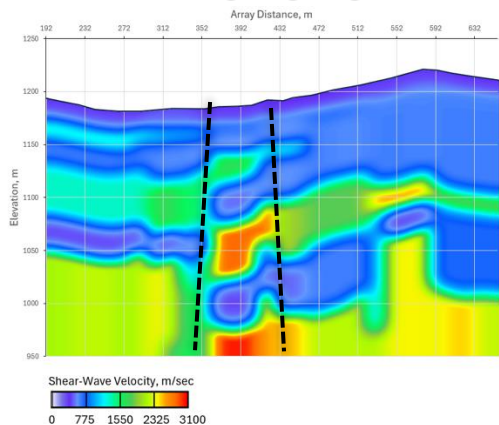
# ReMi® 2dS Sections >200 m Deep at Basin Margins (2x V.E.)
